Manhole Inspection Summary

Manhole # S51A__005MH

Location Address: **front corner 401 n kenwood av**

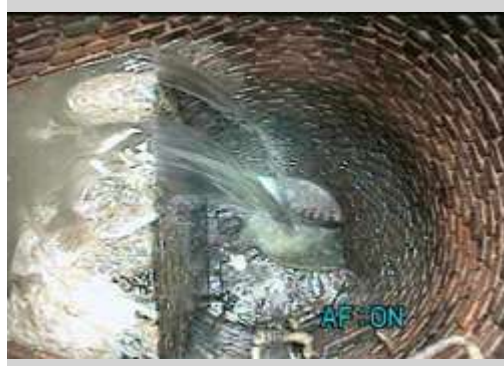
Top View

9 comes out on self

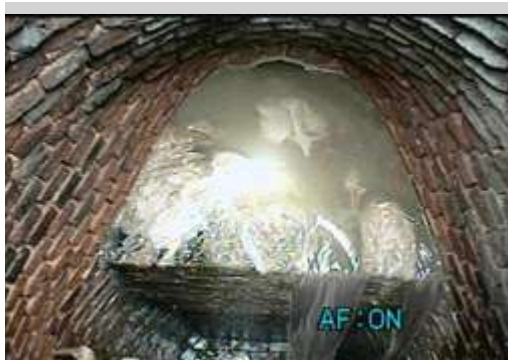
Defect 3

Condition: ☐ Sound ☐ Cracked ☐ Root Intrusion ☐ Deteriorated ☐ Leaks ☒ **Debris**

channel debris on 9 self

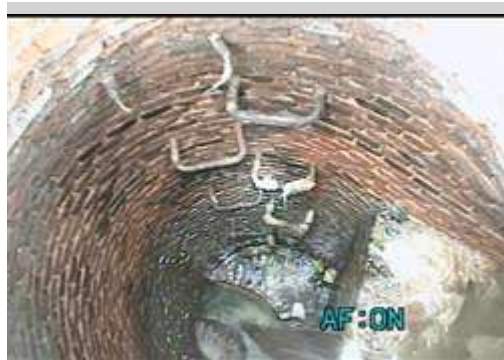
Defect 2

Count: **10** Missing: **2** ☒ **Corroded**

☒ **Evidence Of Surcharge** Depth: **0** (ft.) ☐ Active Surcharge Present

Corroded steps, Surge Evidence

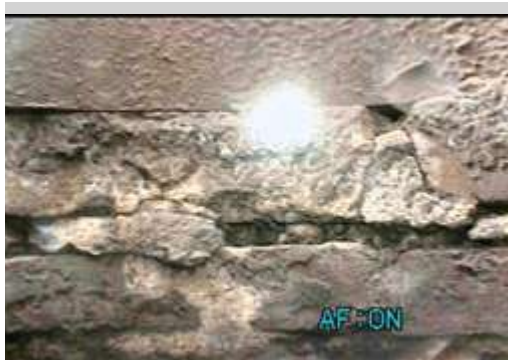
Defect 1

Condition: ☐ Sound ☒ **Cracked** ☐ Root Intrusion ☐ Loose Brick ☒ **Deteriorated**

cracked and deteriorated chimney/frame
adj

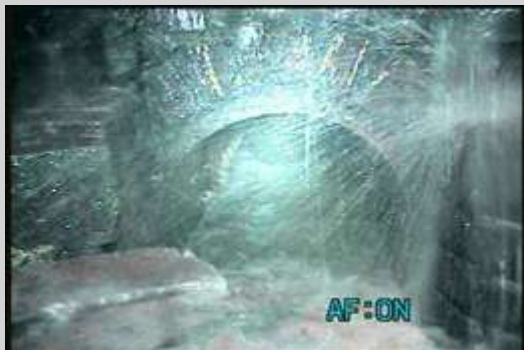
12 O'Clock Outflow

best shot flow dropping from 9

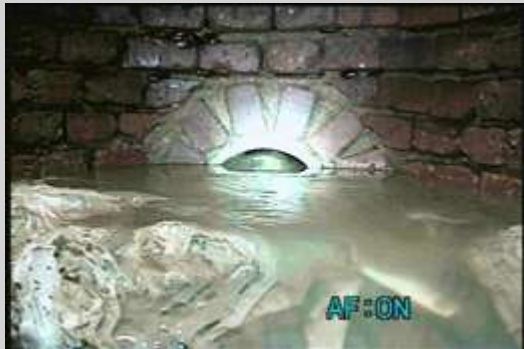
9 O'Clock Inflow

cant see in 9 to much water & debris

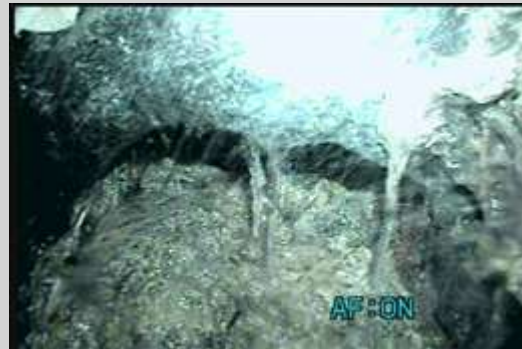
lots of debris in 9 best shot
